# Technical Memorandum

**Date:** 13 November 2009

**Subject:** Historical Storm Water Pipe Investigation  
Glacier Northwest, Inc.-Reichhold, Inc. Site  
5900 West Marginal Way SW, Seattle, Washington

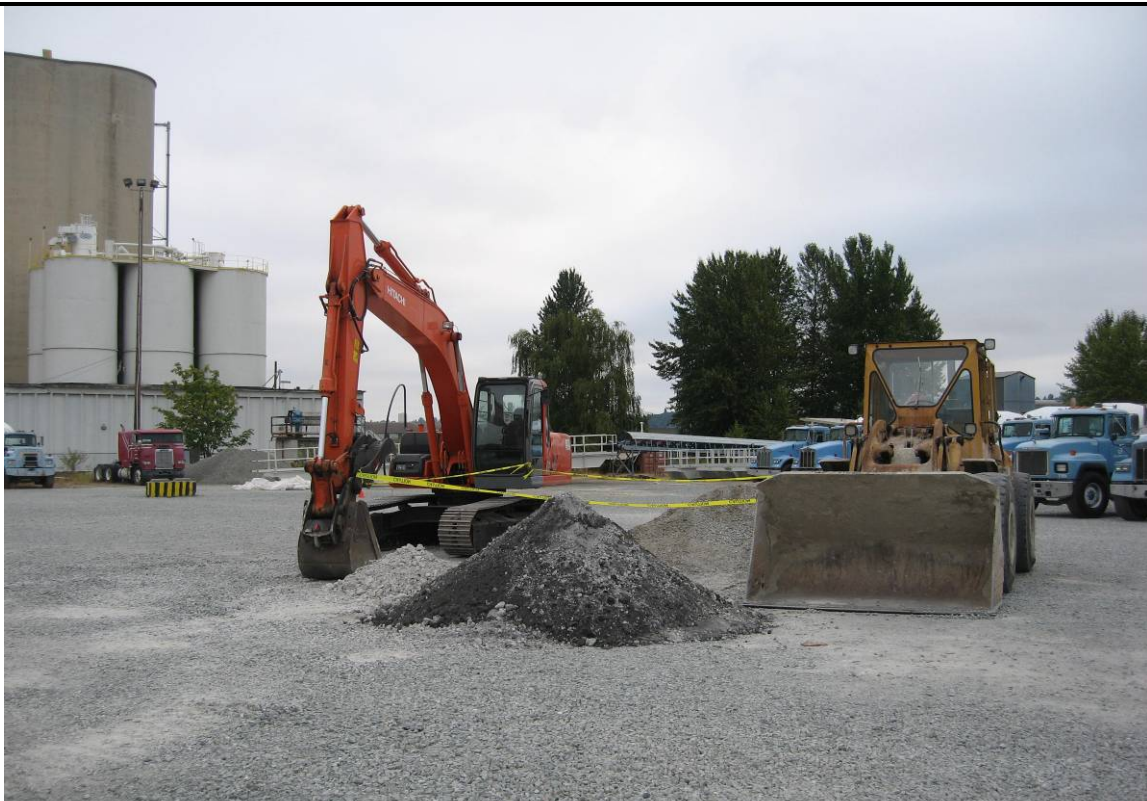
<b>Photograph: 1</b>	Central Excavation Area – looking northeast	
Glacier-Reichhold Site July 2009	<b>ERM</b>	5900 West Marginal Way SW Seattle, WA

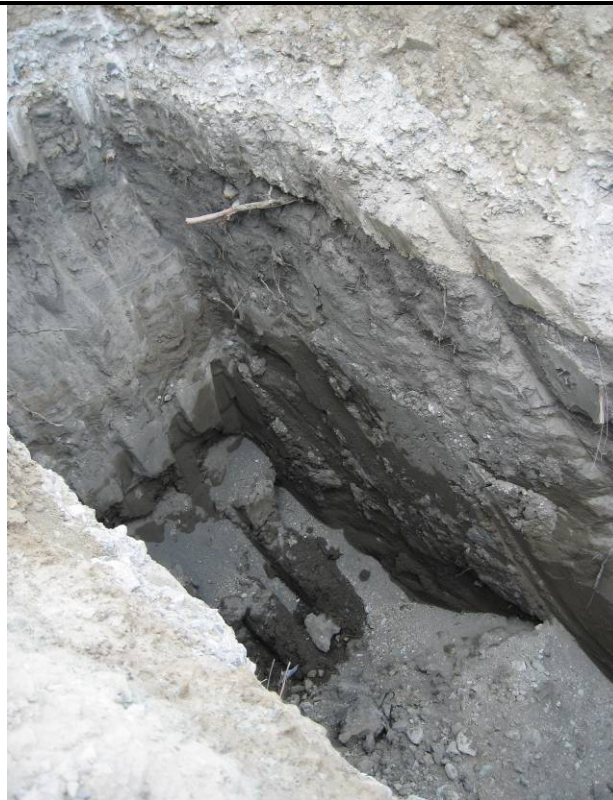
<b>Photograph: 2</b>	Central Excavation Area	
Glacier-Reichhold Site July 2009	<b>ERM</b>	5900 West Marginal Way SW Seattle, WA

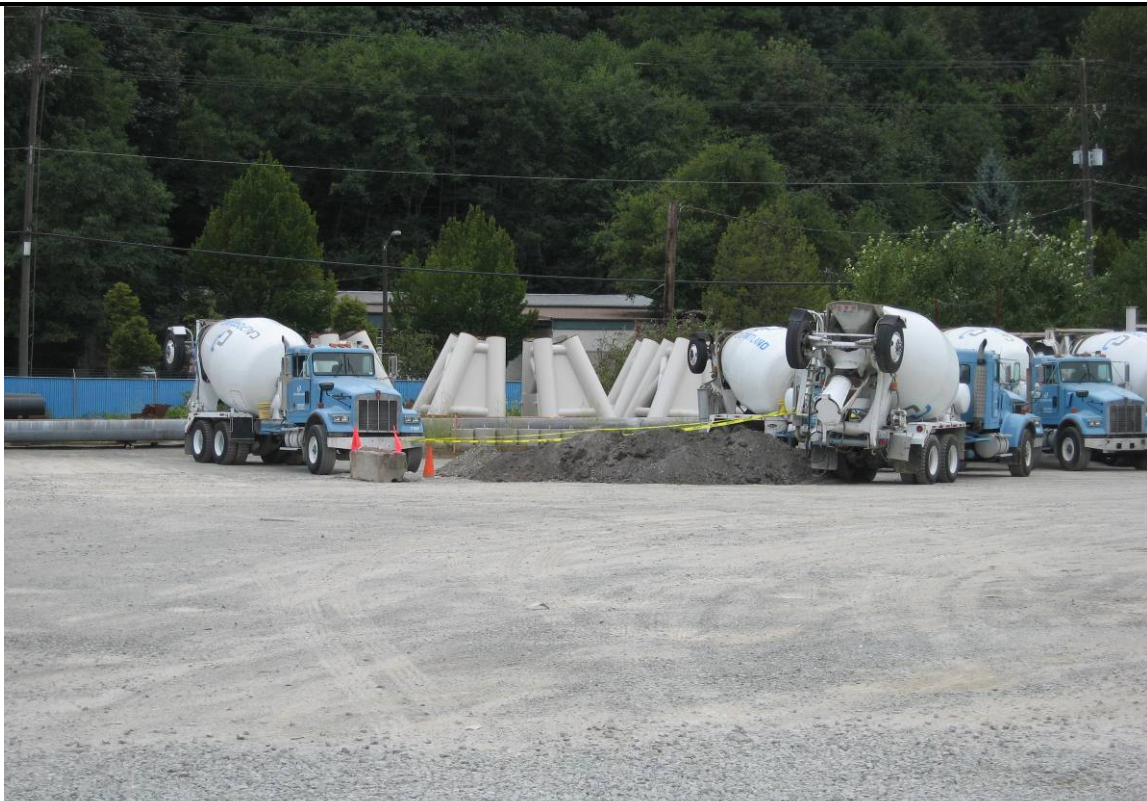
<b>Photograph:</b> 3	Western Excavation Area – looking west	
Glacier-Reichhold Site July 2009	<b>ERM</b>	5900 West Marginal Way SW Seattle, WA

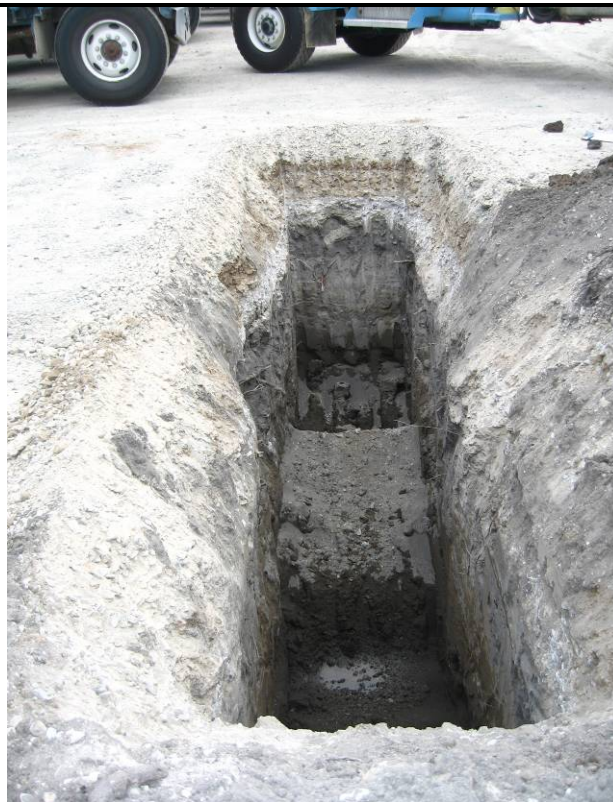
<b>Photograph:</b> 4	Western Excavation Trench	
Glacier-Reichhold Site July 2009	<b>ERM</b>	5900 West Marginal Way SW Seattle, WA

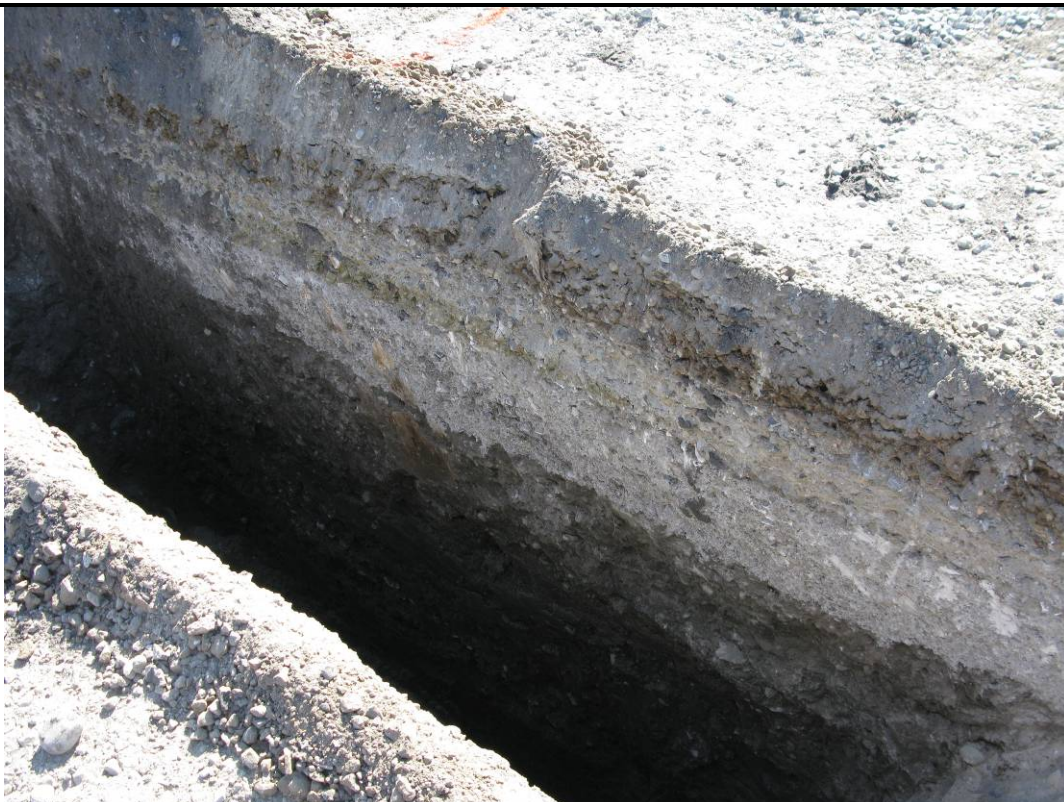
The material in the upper 1 foot of the excavated trench consisted of gravel parking lot surfacing underlain by approximately 1.5 feet of very hard concrete fines/fill. This surface fill material was underlain by dark, silty fines beginning at approximately 2.5 feet below grade. This material is believed to be historically dredged fill material used to grade the Site. At approximately 8 feet below grade, the top of the 15-inch RCP pipe was discovered. The soil around the pipe was carefully cleared to provide

<b>Photograph: 6</b>	<i>Soil Horizons in Pipe Confirmation Trench</i>	
Glacier-Reichhold Site October 2009	<b>ERM</b>	5900 West Marginal Way SW Seattle, WA

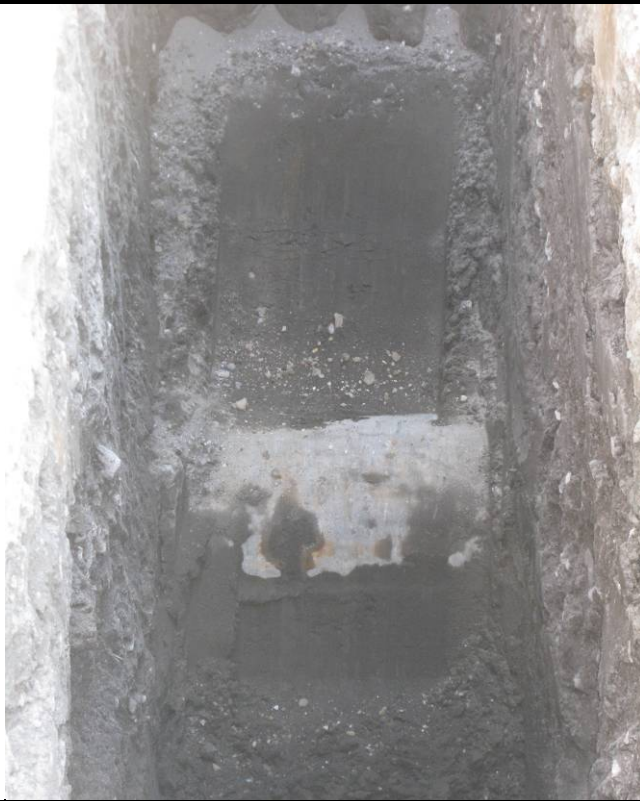
good visual confirmation of the pipe, which appeared to be in very good condition. The soil around the pipe was identified as the dark, silty, dredged material observed at a similar depth across the Site. Granular pipe bedding, generally used in standard piping installation construction methods underneath and as fill around the pipes, was not observed around the pipe. The underside of the pipe was not observed as the pipe was only able to be excavated around the sides of the pipe to approximately half its diameter (depth). No water was observed along the exterior of the pipe or in the fill material. Photographs of the trench and storm water pipe are included in Appendix F.

<b>Photograph:</b> 7	Concrete Pipe in Southern Trench		
Glacier-Reichhold Site October 2009	<b>ERM</b>		5900 West Marginal Way SW Seattle, WA

This investigation was completed to gather information on the presence, alignment, and condition the noted historical storm water pipe and catch basins at the Site. As a result of this investigation which included a records review, an in-pipe camera survey, and multiple test pit excavations, it is recommended that the 15-inch pipe which was located be abandoned by cutting and capping the pipe near the south entrance of the property, as well as obtaining any permits identified by the City of Seattle required to complete the abandonment in this manner.

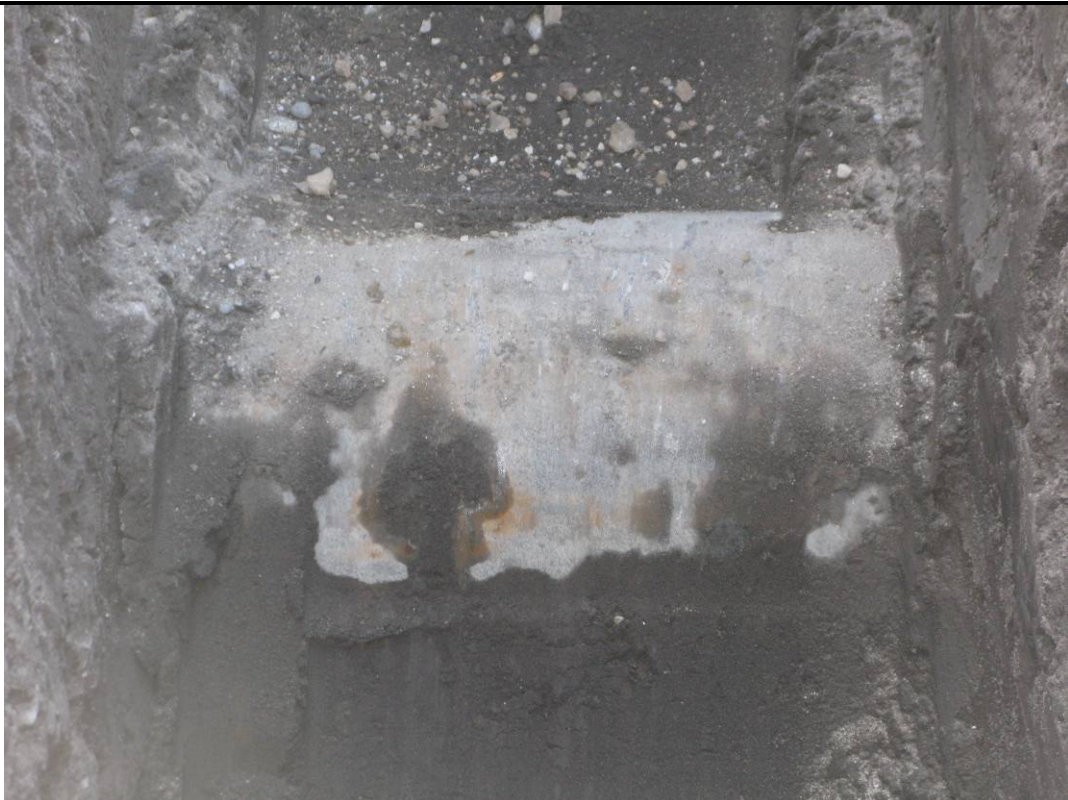
- Granular pipe bedding material was not observed around the storm water piping exposed during this investigation, which would need to be present to act as a preferential pathway;
- The external portions of the 15-inch RCP pipe exposed during this investigation appeared to be in very good condition, which prevents potential contaminants from surrounding fill material from entering the storm water pipe and migrating off-site;
- According to the as-built drawings, the storm water piping and catch basins were installed in 1975, which post-dates historical production operations at the Site; and
- The 15-inch RCP pipe is not part of Glacier's current storm water collection system and there has been no industrial development of the southern portion of the Site.

<b>Photograph:</b> 8	Close-up of Concrete Pipe in Southern Trench		
Glacier-Reichhold Site October 2009	<b>ERM</b>		5900 West Marginal Way SW Seattle, WA
